**Annual Inspection Report**

**Lawrence County Airport**

# ANNUAL INSPECTION REPORT MAY 4, 2011

LAWRENCE COUNTY MUNICIPAL AIRPORT COURTLAND, ALABAMA

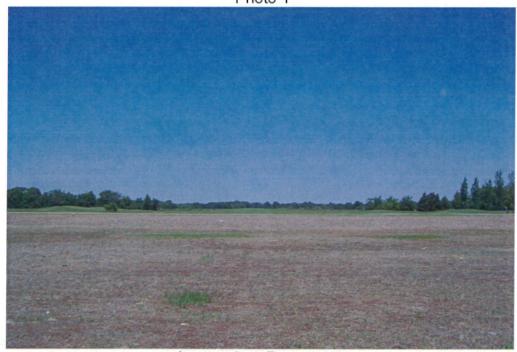
Photo 1

Approach to Runway 17 Photo 2

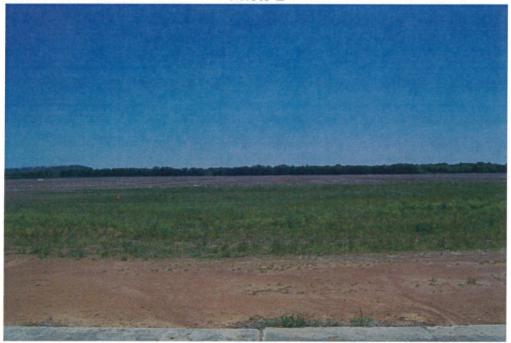
Approach to Runway 35

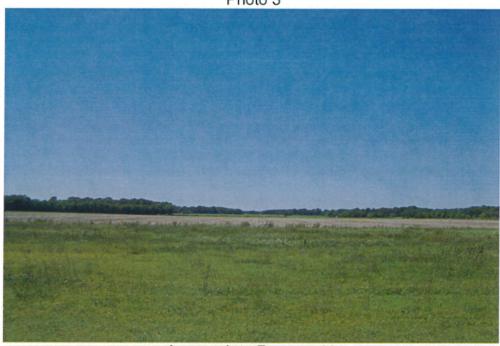
Approach to Runway 13

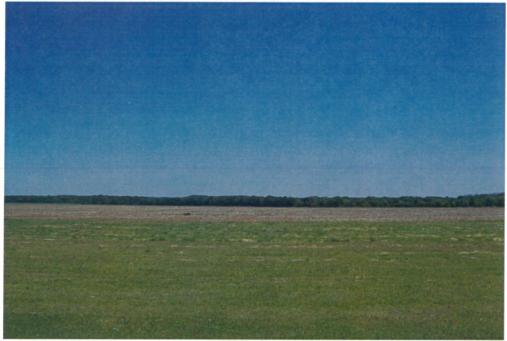
Photo 4

Approach to Runway 31

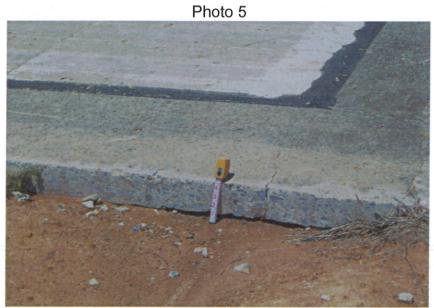
→ The drop along the runway end of Runway 35 was found to be as much as 6 inches.

Tape showing 5/10's of a foot drop adjacent to runway end of Runway 35

→ The area adjacent to the runway end must be filled, compacted and graded to a maximum of a three inch drop to meet the minimum licensing requirements.

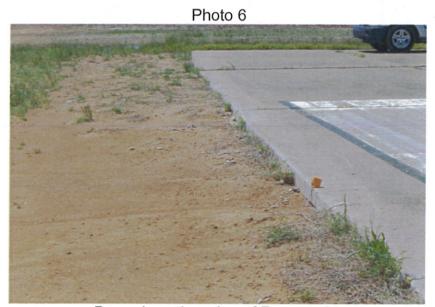
Drop along the edge of Runway 35

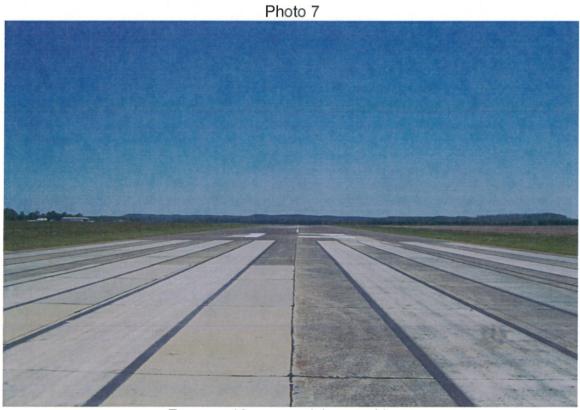
Runway 13 nonprecision markings

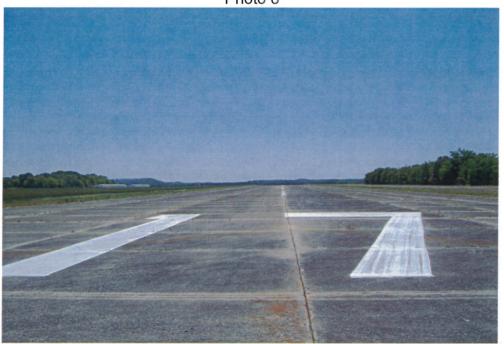
Runway 17 basic markings

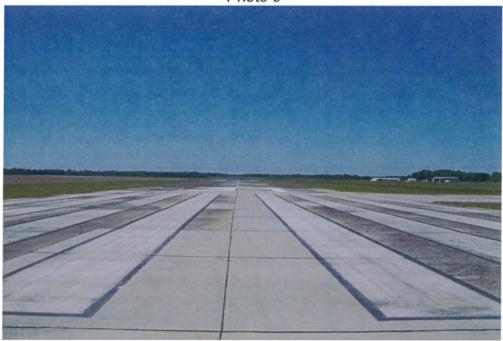
Photo 9

Runway 31 nonprecision markings

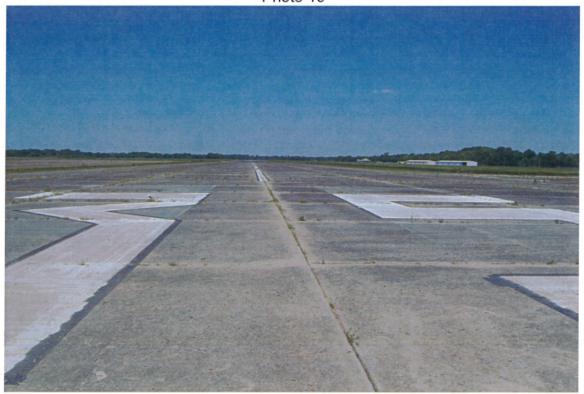
Runway Identifier markings of Runway 35

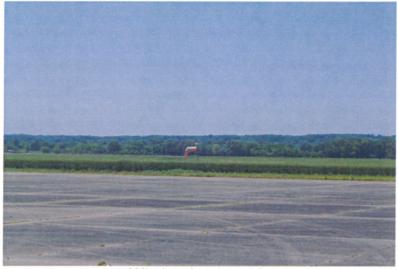
Windsock assembly

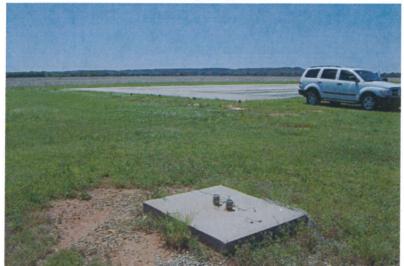
→ One REIL is missing on each end of Runway 13/31.

Concrete base and wiring of missing REIL on Runway 17

→ Replace the 2 missing units.

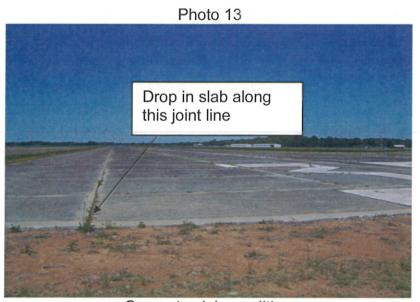
A section of the concrete slabs at the threshold of Runway 35 has dropped and created a drop along the intersection of the adjacent slabs. This drop also created a long section between the slabs that has no joint filler and uneven section of runway.

Concrete slab condition

- → This item should be discussed with the airport consultant. This condition could quickly become a safety issue as directional control of an aircraft could be affected.
- → Relocation of this runway end is an option in lieu of major construction.

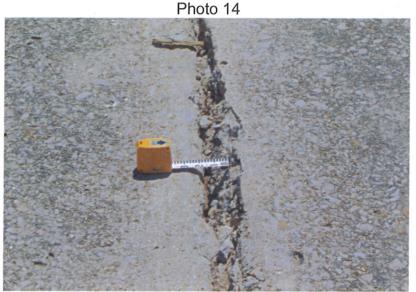
Joint line along the shift in the slab

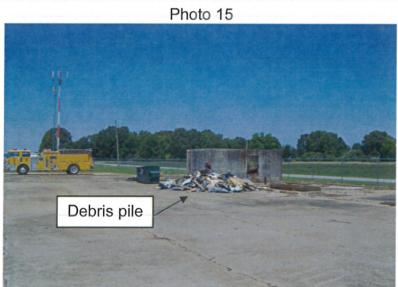
Debris removed from the airport operational areas

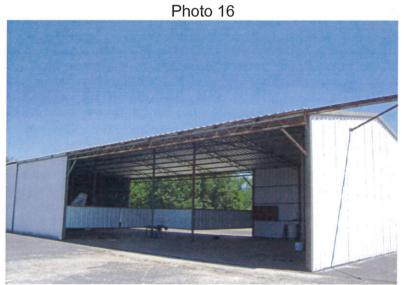
Hangar doors missing on both sides of hangar due to storm
